UNITED STATES AIR FORCE
AIRCRAFT ACCIDENT INVESTIGATION
BOARD REPORT

B-52H, T/N 60-053

LOCATION: 30 NAUTICAL MILES NORTHWEST OF GUAM

DATE OF ACCIDENT: 21 JULY 2008

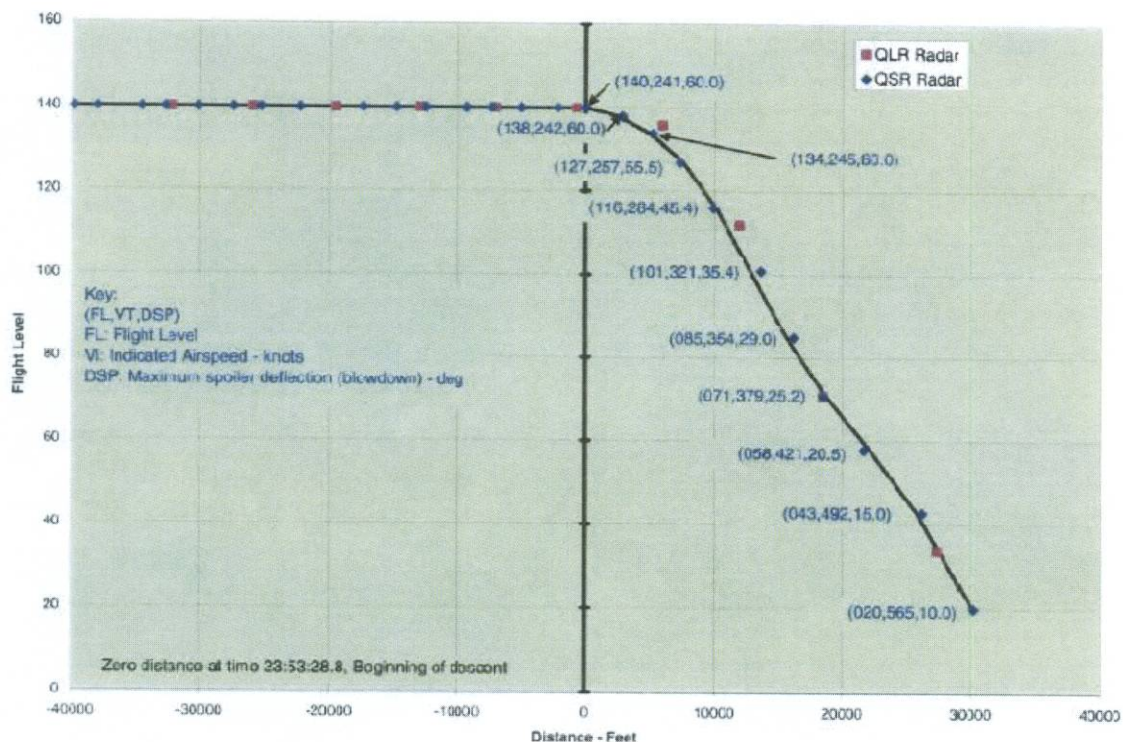
Figure 2 - MA Descent Profile

A debris field was found at North 13 49.930 East 144 26.700, an area 30 NM northwest of Guam (Tab O-3). It was described as approximately 400 yards long by 150 yards wide (Tabs O-42, R-8, R-33, S-3 - S-4, S-9). Very little data exists regarding the MA's flight parameters at impact. However, Boeing, the manufacturer of the MA, used ATC radar data that included latitude and longitude, altitude from the MA's on board transponder, and time data to develop a model that would approximate the MA's flight path beginning at 14,000 feet mean sea level (MSL) down to its last reported position on radar, approximately 2,000 feet MSL (Tabs J-23, M-3 - M-264; Figure 2). Additionally, temperature data for the day and area of the accident was obtained for airspeed calculations (Tab J-23). The resulting descent profile depicts a rapid descent from 14,000 feet down to the surface of the ocean over a very short ground distance of approximately 5 NM. At impact, the MA had exceeded its maximum operational airspeed and entered the ocean at a steep angle (Tab J-23 - J-24).

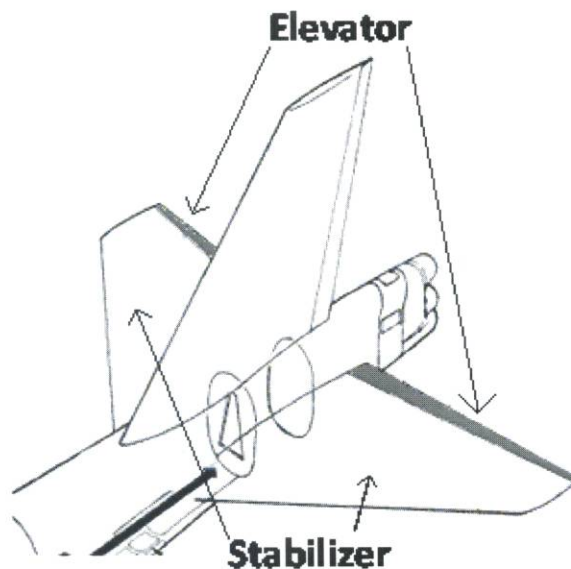
Figure 4: Elevator and Stabilizer Trim

The MA's jackscrew was recovered during salvage operations. The jackscrew is a component of the stabilizer trim system (Tab CC-18). Analysis of the jackscrew revealed the MA stabilizer trim was set at 4.5-5.0 degrees nose down at impact. There was damage to the jackscrew that occurred during impact (Tabs J-216 - J-219, J-222). Additionally, the stabilizer trim actuator (motor) and other items normally attached to the jackscrew assembly were not recovered. The absence of these items makes it impossible to determine why the stabilizer trim was set to 4.5-5.0 degrees nose down at impact or whether it was functioning properly.

The elevator and stabilizer trim are control surfaces that are located on the tail of the aircraft (Figure 4). They are used together in order to maintain pitch of the aircraft. Normally, the pilot uses his elevator to control pitch initially and then will use stabilizer trim to relieve control forces. The elevator is controlled by the yoke; the control surface moves through a system of pulleys, cables and hydraulic actuators (motors). The stabilizer trim is controlled primarily through the use of a switch on the yoke; it is controlled through electrical switches that control the stabilizer trim actuator (motor) (Tab DD-3). The stabilizer trim control system provides pitch trim by movement of the entire horizontal stabilizer surface (Tab J-67). There is a manual control wheel that can be used in an emergency situation when the electrical trim function is not available. The elevator and stabilizer trim control surfaces are normally used in sequence during all phases of flying, and techniques for proper utilization are taught throughout a pilot's career (DD-3).

The evidence indicates that the stab trim was set at ~5.0 degrees nose low at impact. This indicates an improper stab trim setting of an aircraft in a nose low descent at low altitude. However, with no eyewitness accounts, surviving aircrew members, emergency radio calls or "black box" recordings, and minimum recovered aircraft control surfaces/instruments, the specific reason the stab trim is in an improper position cannot be determined.
